EXPLORATORY DEVELOPMENT STUDIES FOR SUSTAINED LOAD SUBCRITICAL CRACK GROWTH IN TITANIUM ALLOYS

LOCKHEED-CALIFORNIA COMPANY
P. O. BOX 551
BURBANK, CALIFORNIA 91520

AUGUST 1977

TECHNICAL REPORT AFML-TR-77-143
Final Report for Period April 1976 - June 1977

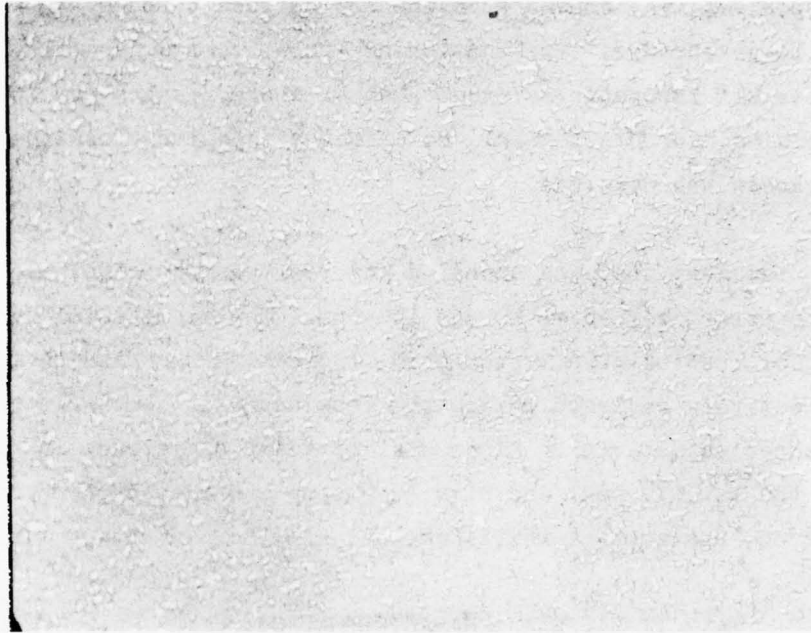
Figure 3. Typical Microstructure of the High Hydrogen (206 ppm)
Solution-treated and Aged (STA) Material, Plate Surface Plane

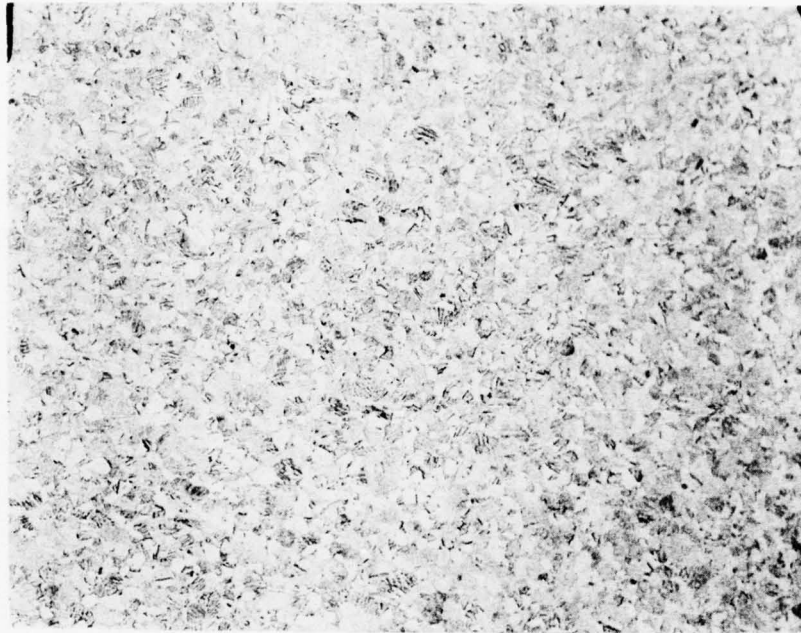
Figure 4. Typical Microstructure of the High Hydrogen (245 ppm) Recrystallize Annealed (RA) Material, Plate Surface Plane

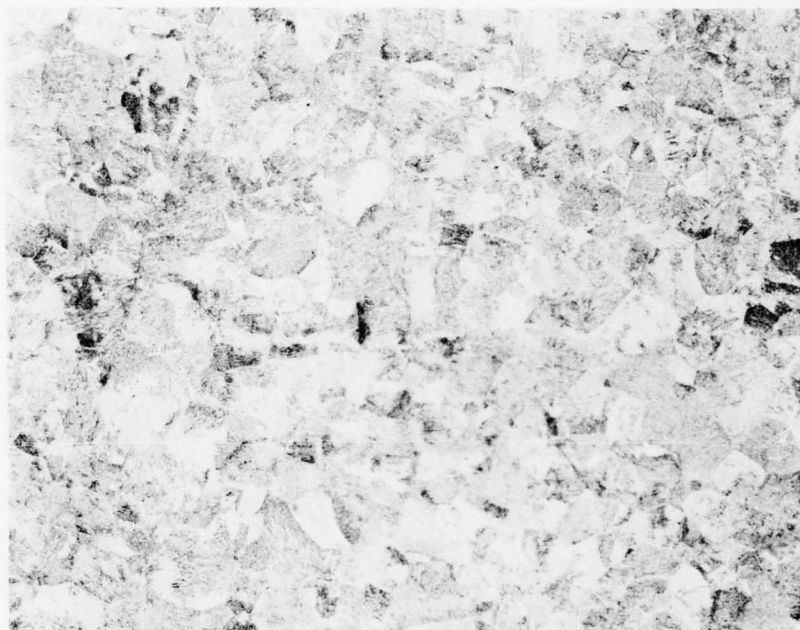
Figure 5. Typical Microstructure of the High Hydrogen (199 ppm) Beta Annealed Material, (β), Plate Surface Plane

Metallographic sections were prepared from 1 x 3 x 1½-inch material blocks, one of which accompanied each of the five heat treat runs. Three orthogonal sections from each specimen were polished and etched with a solution of 5% HF in methyl alcohol for the RA and β heat treatments and 1% HF + 2% HNO₃ in methyl alcohol for the STA material. Photomicrographs of the specimen surface planes are shown in Figures 3 through 7. Examination indicates the microstructures are typical of the respective heat treatments. Figure 3 shows equiaxed primary alpha typical of the solution treated and aged condition. Figures 4 and 6 both exhibit equiaxed alpha in a transformed beta matrix containing coarse, acicular alpha, typical of the recrystallized annealed condition. Figures 5 and 7 both show a typical transformed beta microstructure typical of beta annealed material.

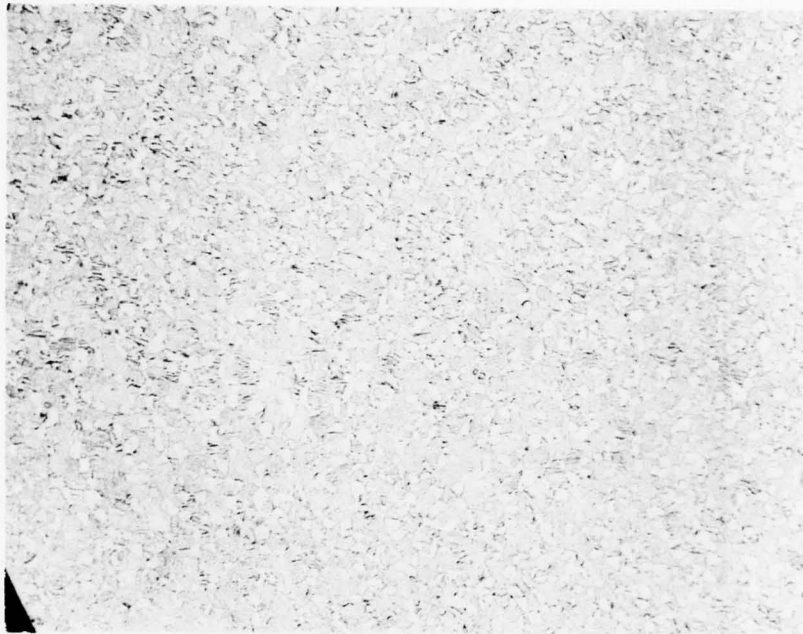
Figure 6. Typical Microstructure of the Low Hydrogen (72 ppm)
Recrystallized Annealed (RA) Material, Plate Surface Plane

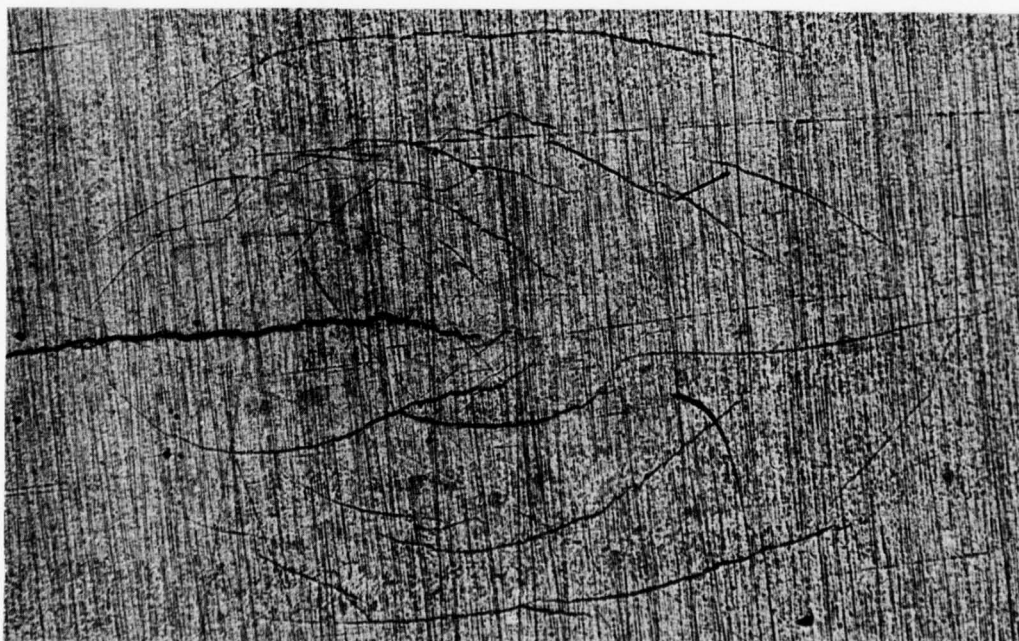
Figure 18. Typical Crack Tip Cracking in Dry Argon for
RA Materials, Specimen A-1-117

Rear Surface

Front Surface

Results for both materials in $3\frac{1}{2}\%$ NaCl solution showed rapid crack extension to occur to failure at initial stress intensities greater than an apparent threshold value. At initial stress intensities below the apparent threshold, a region is encountered where the crack grows rapidly at the start of the test, the growth rate then slowing and finally going to zero after approximately 10 to 15 minutes, no further crack growth then occurring for the duration of the test. Post test examination of the crack path of specimens that arrest showed the formation of multiple "fingers" of crack growth all along the crack front as shown schematically in Figure 20. This indicates that as the cracking causes splitting along grain boundaries parallel to the

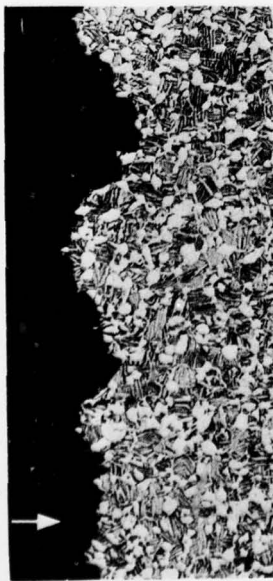
Figure 26. Metallographic Section Results for Ti-6Al-4V(RA) Material Tested in Dry Argon

Pre-crack → Crack Growth

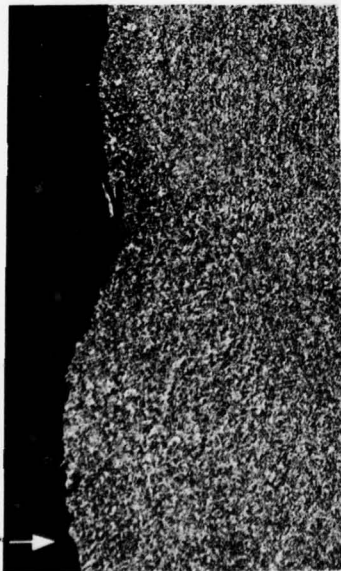
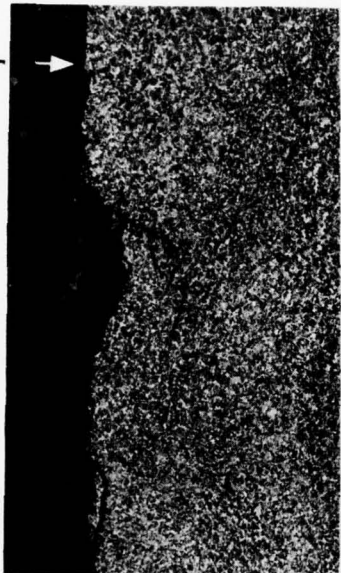
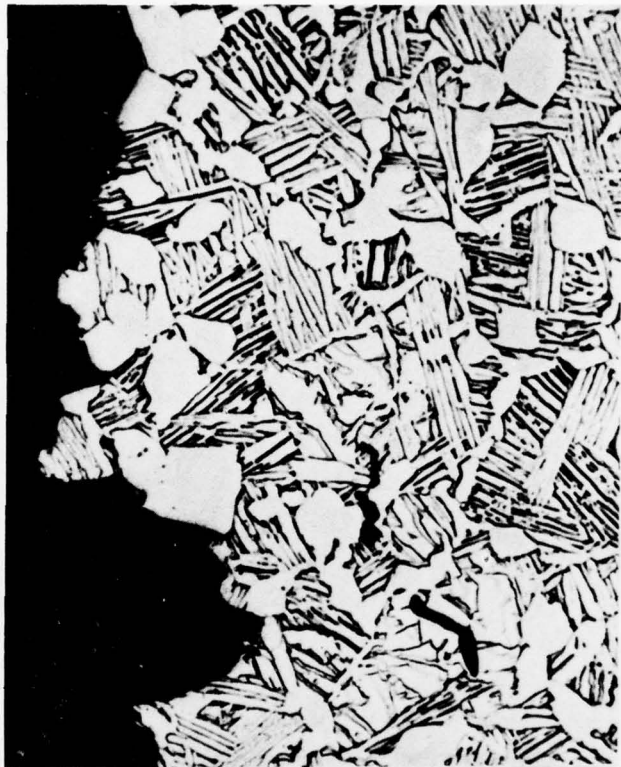
Figure 28. Metallographic Section Results for Ti-6Al-4V(PA) Material Tested in 3½% NaCl Solution

Crack Growth

a. Specimen A-1-113 (72 ppm Hydrogen)

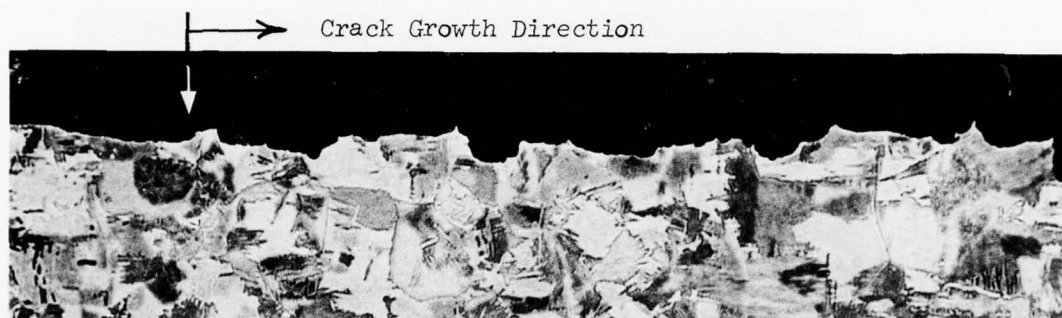
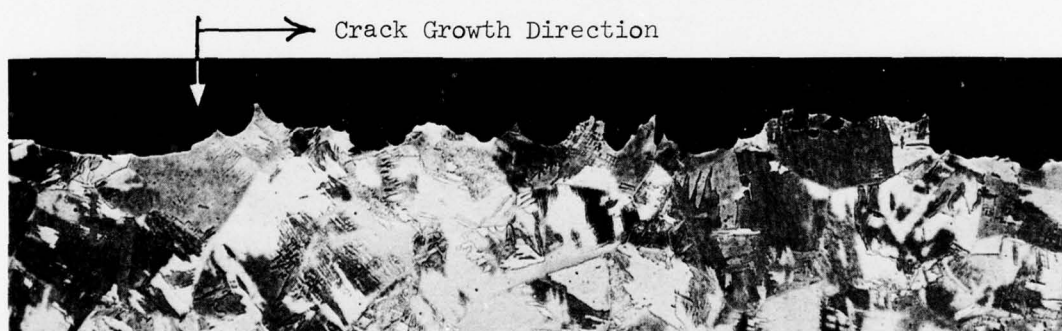
Figure 30. Metallographic Sections Showing Crack Propagation Regions in Ti-6Al-4V(β) Material (199 ppm Hydrogen), 25X

a. Specimen B-1-7, High Humidity Air, $K_{Ii} = 70.5 \text{ ksi } \sqrt{\text{in.}}$

b. Specimen B-1-22, Dry Argon, $K_{Ii} = 75.0 \text{ ksi } \sqrt{\text{in.}}$

c. Specimen B-1-16, $3\frac{1}{2}\%$ NaCl Solution, $K_{Ii} = 40.3 \text{ ksi } \sqrt{\text{in.}}$

studied. The results show similar fracture surface features of specimens tested in the high humidity air and dry argon environments, the results in dry argon showing somewhat more ductile rupture mixed with the cleavage. Results in $3\frac{1}{2}\%$ NaCl solution for specimen B-1-16 (which grew and arrested) show extensive crack tip branching in the region of crack arrest. Fracture surfaces show primarily cleavage features, the majority of which occur normal to the alpha colonies. Examination of the fracture surface features of the low hydrogen level material (24 ppm) shown in Figures 34, 35 and 36 reveals fracture features essentially the same as those found in the high hydrogen material tested in the same environment.

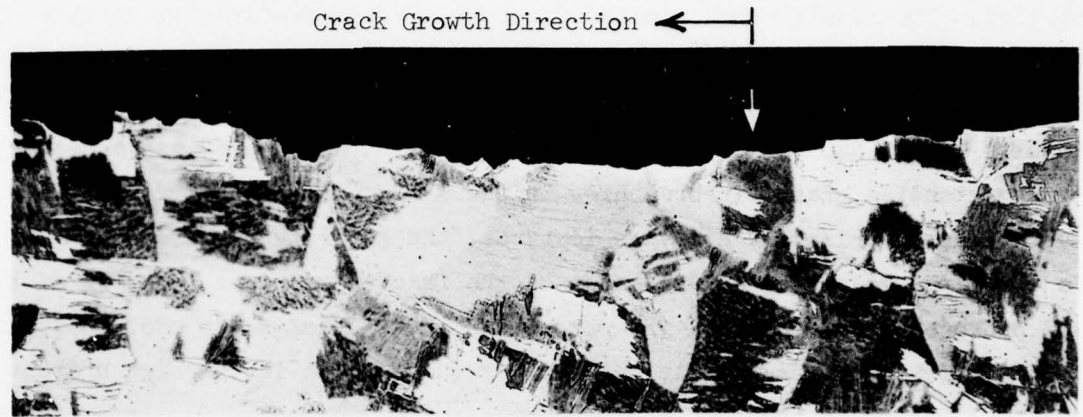
Figure 34. Metallographic Section Results for Low Hydrogen Level (24 ppm) Beta Annealed Materials, 25X

a. Specimen B-1-114, High Humidity Air, $K_{Ii} = 79.3 \text{ ksi } \sqrt{\text{in.}}$

b. Specimen B-1-123, Dry Argon, $K_{Ii} = 78.0 \text{ ksi } \sqrt{\text{in.}}$

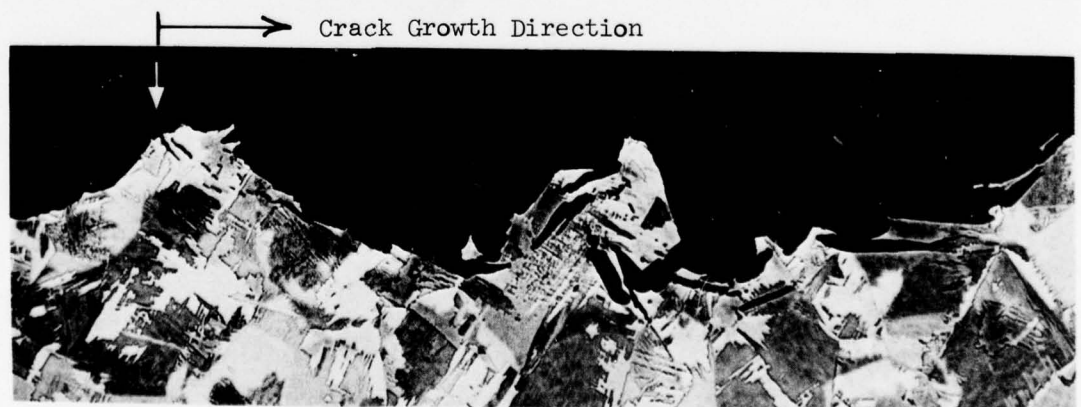
c. Specimen B-1-112, $3\frac{1}{2}\%$ NaCl Solution, $K_{Ii} = 54.7 \text{ ksi } \sqrt{\text{in.}}$

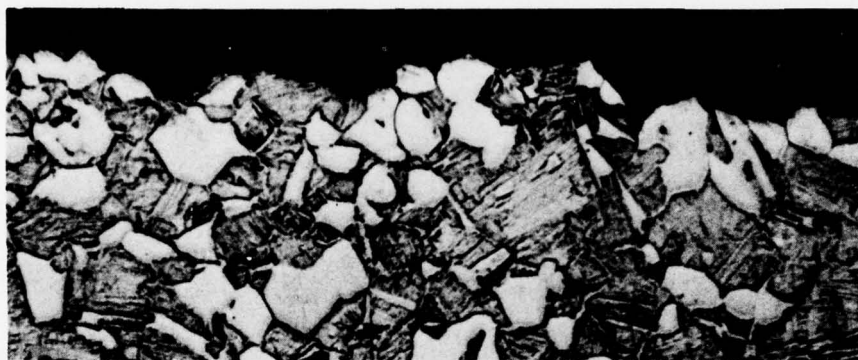
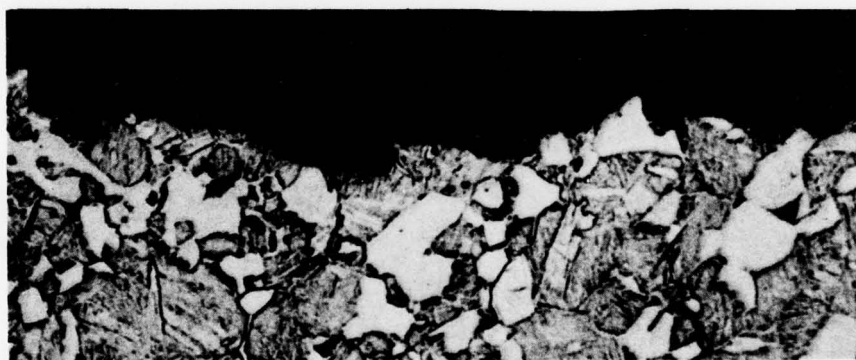
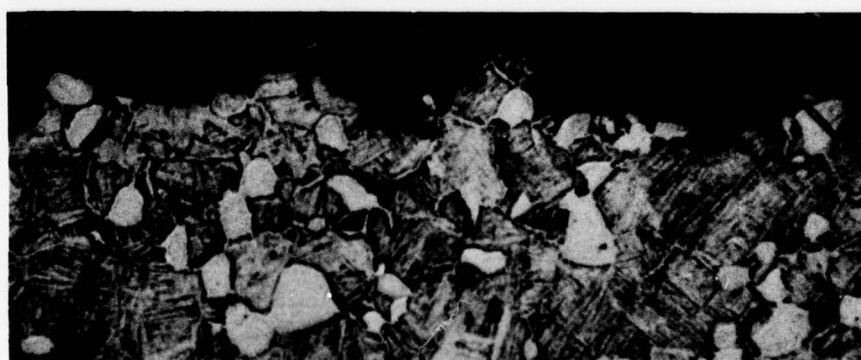
Figure 37. Metallographic Sections of Sustained Load Crack Growth Region in Ti-6Al-4V(STA), 500X

a. Specimen S-3-36, High Humidity Air, $K_{Ii} = 55.9 \text{ ksi } \sqrt{\text{in.}}$

b. Specimen S-3-39, Dry Argon, $K_{Ii} = 57.2 \text{ ksi } \sqrt{\text{in.}}$

c. Specimen S-3-61, $3\frac{1}{2}\%$ NaCl Solution, $K_{Ii} = 31.7 \text{ ksi } \sqrt{\text{in.}}$

Figure 37 shows the metallographic sections through the sustained load crack growth region in various environments. The results are consistent with those of the RA and beta materials in that the extent of cleavage of the alpha is more extensive in $3\frac{1}{2}\%$ NaCl solution. The results in high humidity and dry argon are again similar.
